Identification and Improvement of Accident Black Spots on N.H.- 3 District Una, Himachal Pradesh – A Case Study

Map 1.1: Black spots on N.H.-3 from Gagret to Amb.

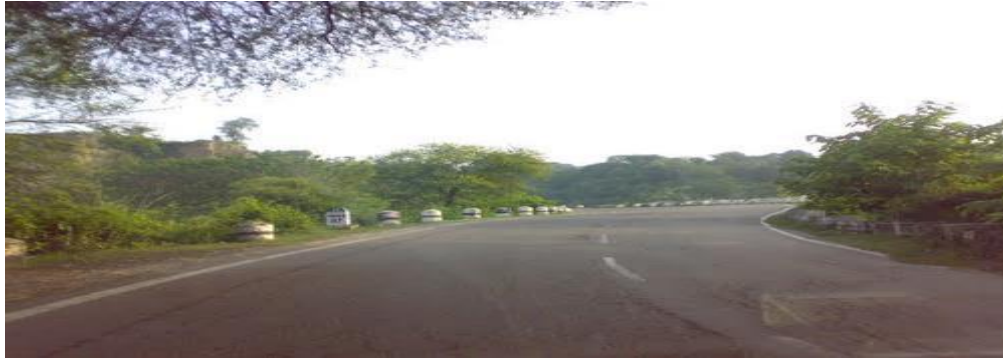
Fig 1.1: National Highway – 3.

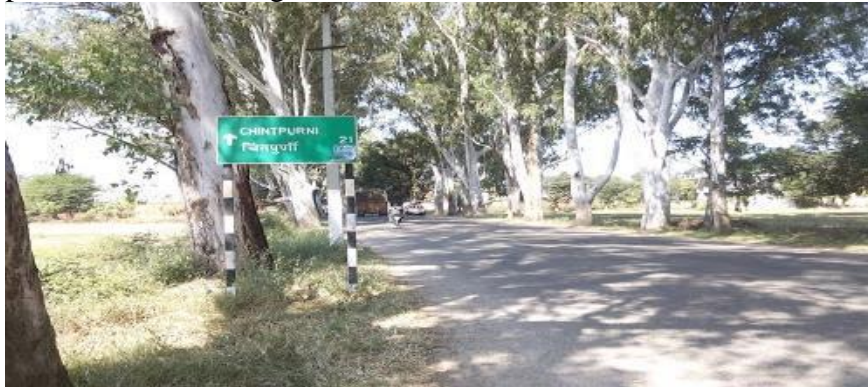
Fig 1.2: National Highway-3 with Sign Board.

During the signage inventory it is observed that on most of the required places the sign boards are absent like sign board before narrow bridge, right/left turn etc. and also on some places the boards are in poor conditions.

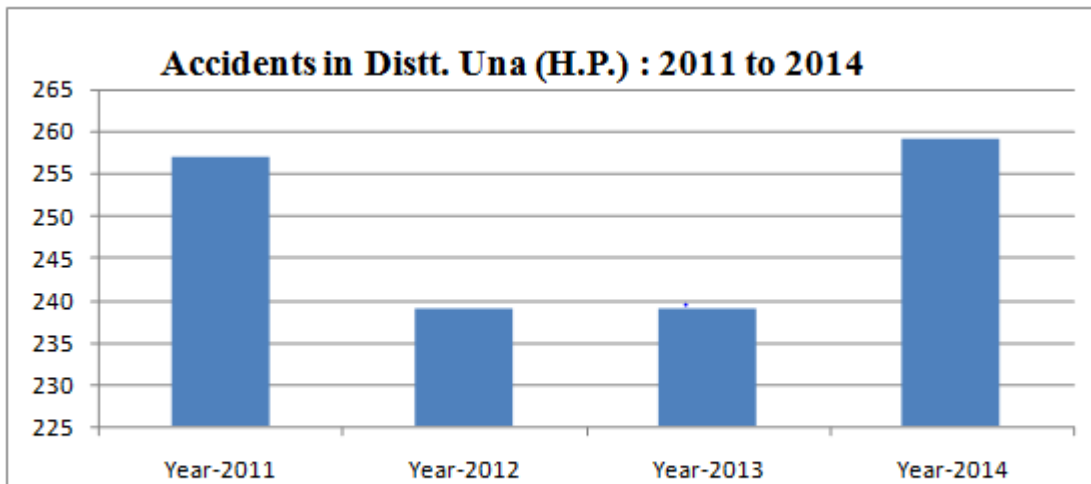
Fig 1.3: Road Accidents in Distt. Una (Himachal Pradesh) : 2011 to 2014.

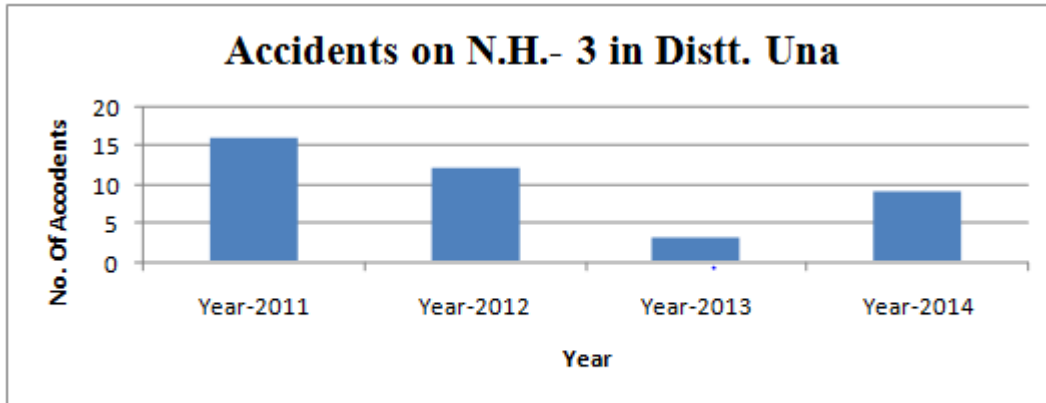
Fig 1.4: Road Accidents on N.H.-3 in Distt. Una (Himachal Pradesh): 2011 to 2014.
 Source: Office of the Superintendent of Police Una, Distt. Una (H.P.).

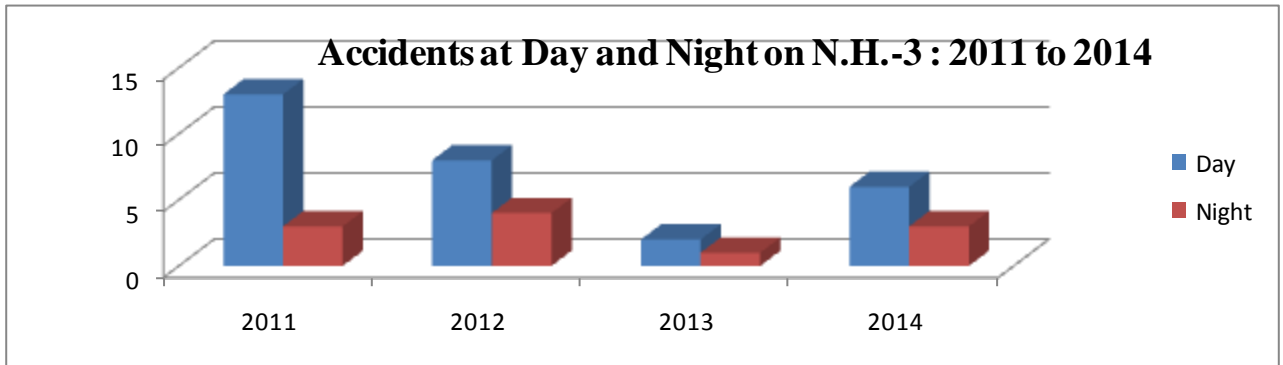
Fig 1.5 : Number of Accidents at Day or Night on NH- 3 : 2011 to 2014.
Source : Office of the Superintendent of Police Una, Distt. Una (H.P.).

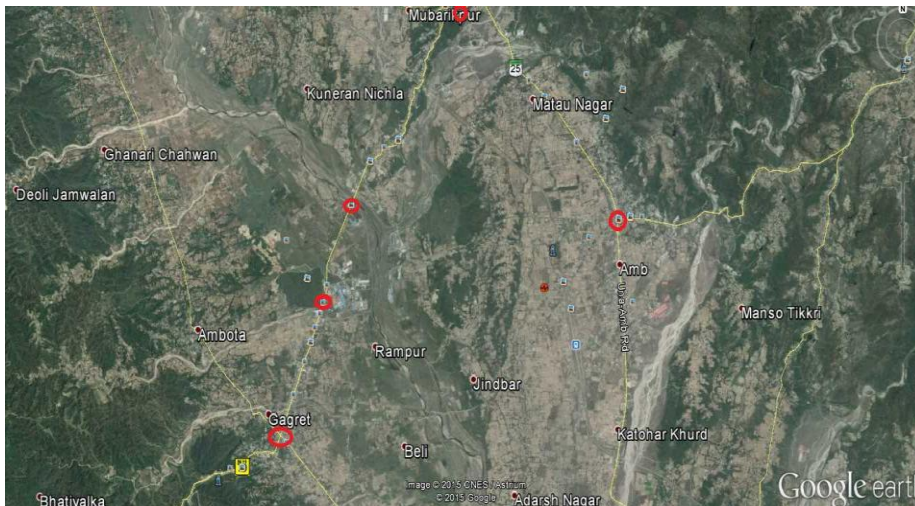
The WSI value of Shiv bari is highest so it means that Shiv bari spot is more dangerous than other spots. After that Mubarakpur, Gagret city, near Alfa hotel and in last Amb spot.

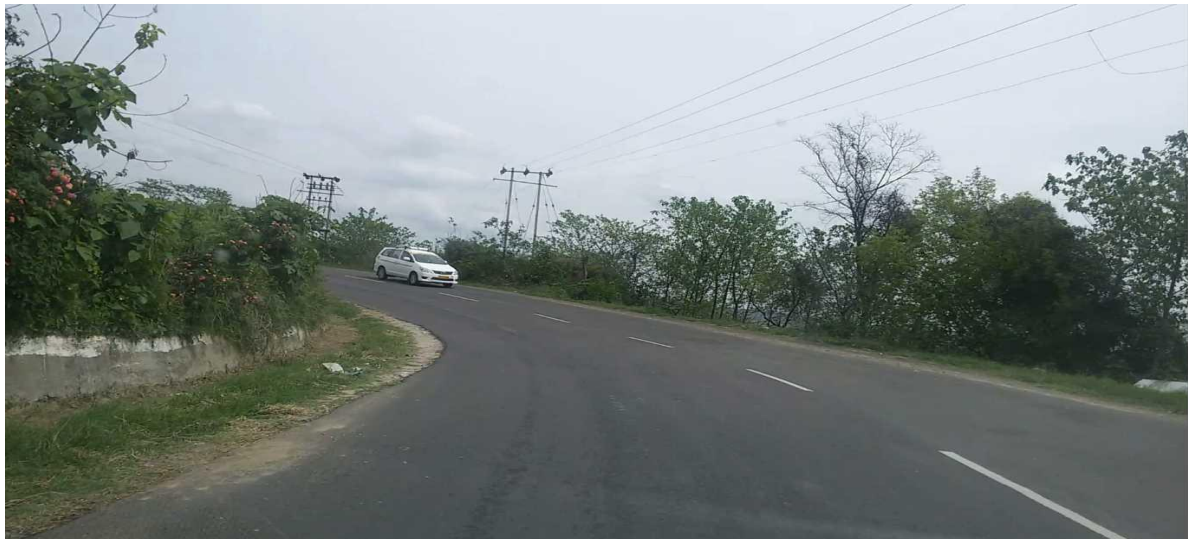
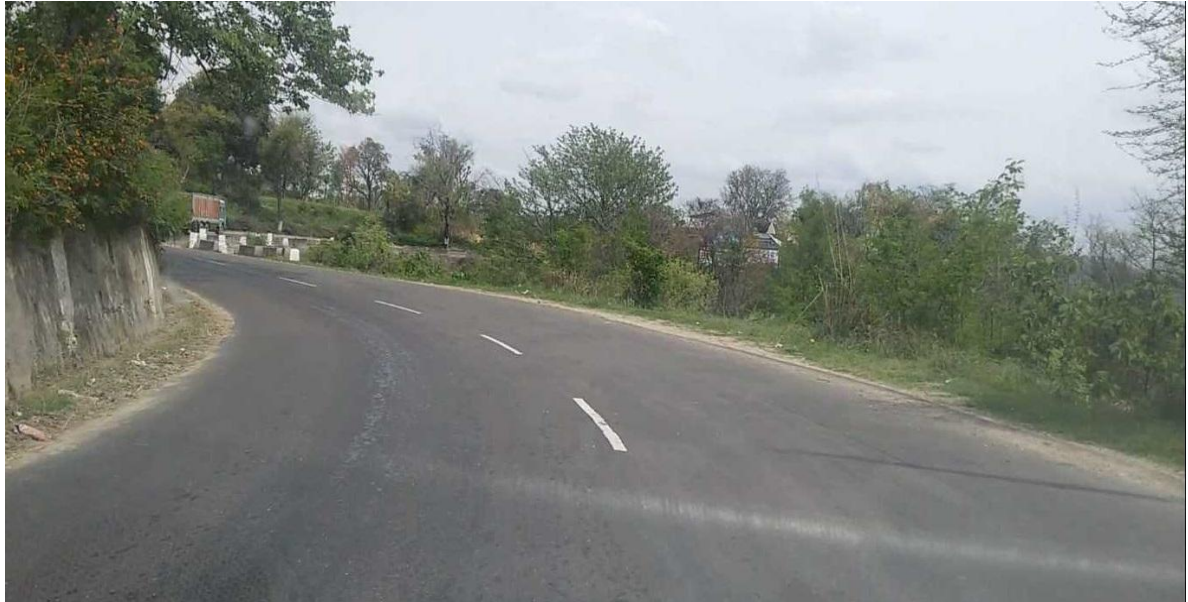
Fig 1.6: Shiv bari accident locations.
Source: Site visit photography.

- Identified stretch has the necessary lane width and condition of road is also good. But absence of shoulder is the main cause of accidents.
- The marking is absent on the left & right side of the road.

1. Provide the shoulder of width 1.0 m on hill side and 2.0 m on valley side in Mountainous Terrain.
2. Roadway Width in Mountainous Terrain is 10.0 m (exclusive of parapets and drains).
3. Provide the guard rails on the valley side of the road.
4. Use the sign boards to inform the drivers about the turns, speed etc.
5. Proper marking on roads.
6. We can provide the roadway delineators on the valley side of the road.

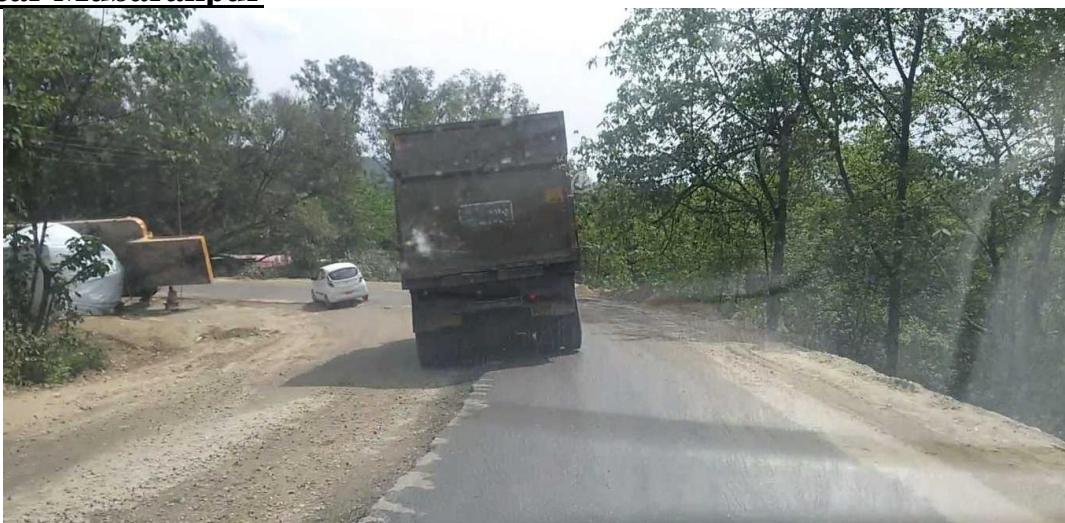
Fig 1.8: Near Mubarakpur (Mubarakpur - Amb Road).
Source: Site visit photography.

- This black spot is near Mubarakpur (Mubarakpur – Amb road). Here the condition of road is poor.
- Right edge of road has more height as compare to the left edge of road may be because of inadequate super elevation design.

- First of all construct the road because the condition of road is poor here.
- Redesign the Super-elevation because here the right side is more raised as compare to the left side. Because of this the unequal pressure on the wheels of vehicles, which result from high value of sideways force between the tyres and the roadway surface. Here the super-elevation is more than 0.12. As per Indian practice the Super-elevation is limited to 0.07-0.10
- Use the sign board on curves to inform the drivers about the curves and also speed limit sign board.

- Provide the shoulder both side of the road.
- Provide the road delineators.

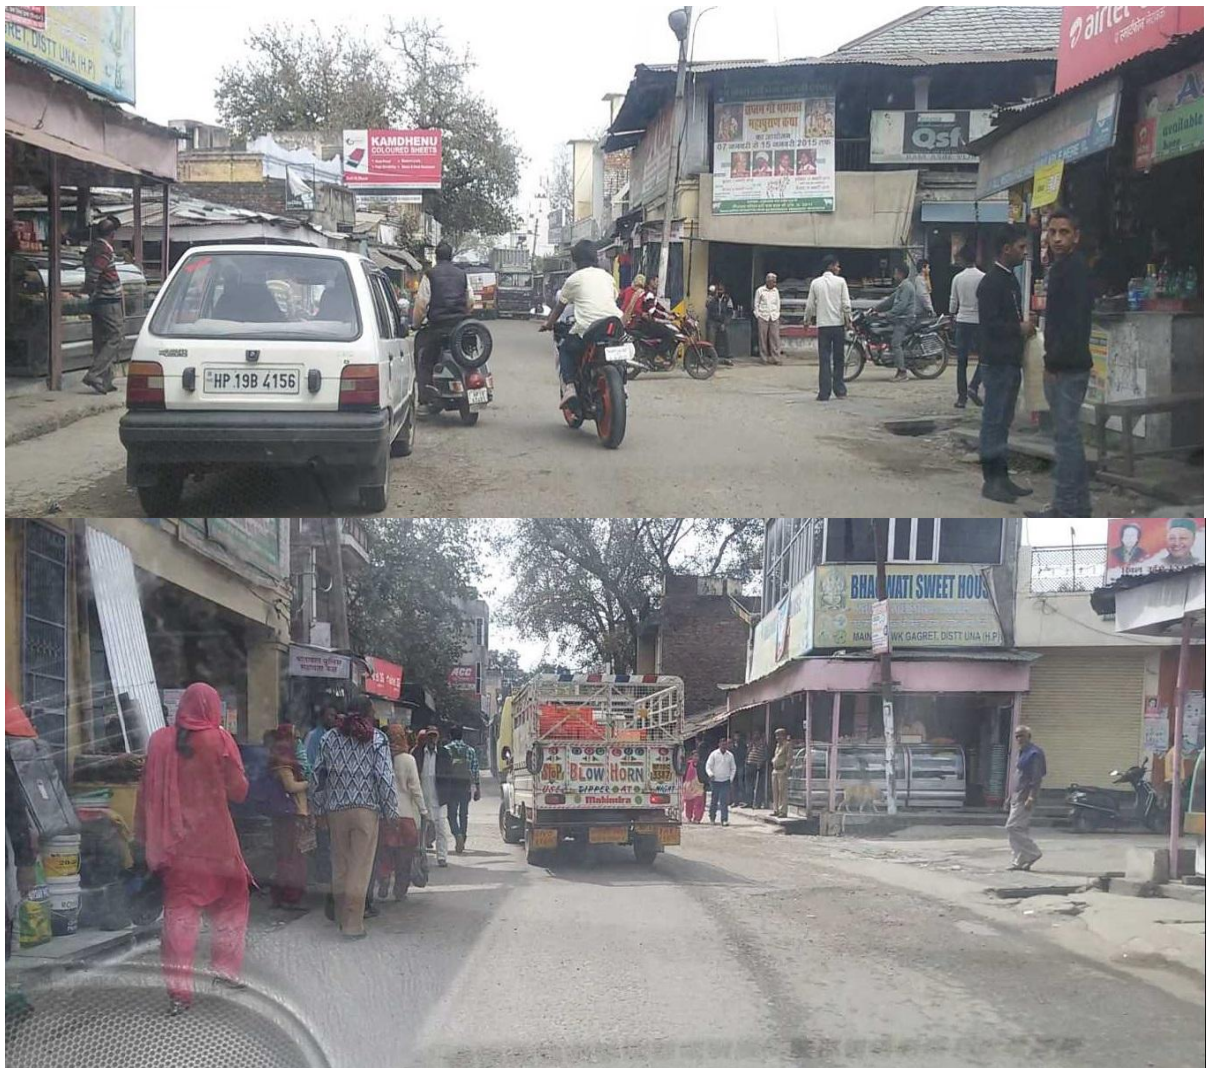
Fig 2.1: Gagret city

- .In the main bazaar of Gagret the width of carriageway is not according to IRC standards for NH.
- Also the shoulder is absent.
- Sight distance is poor.
- Jams also occur here.
- No space for parking.

- Provide the shoulder.
- Because of the peoples walk on the road the sight distance is poor and also due to the shopkeepers takeover the road sides in front of their shops.
- As there is no space available for increase the carriageway width and shoulder, we can suggest the bye-pass for this because of that the jam condition is also decrease in the main bazaar of Gagret.
- Provide the speed limit sign board.
- As there is no chance of providing the traffic signals, rotary, the traffic police

should be there for safe movements of traffic.

- Provide the space for parking.

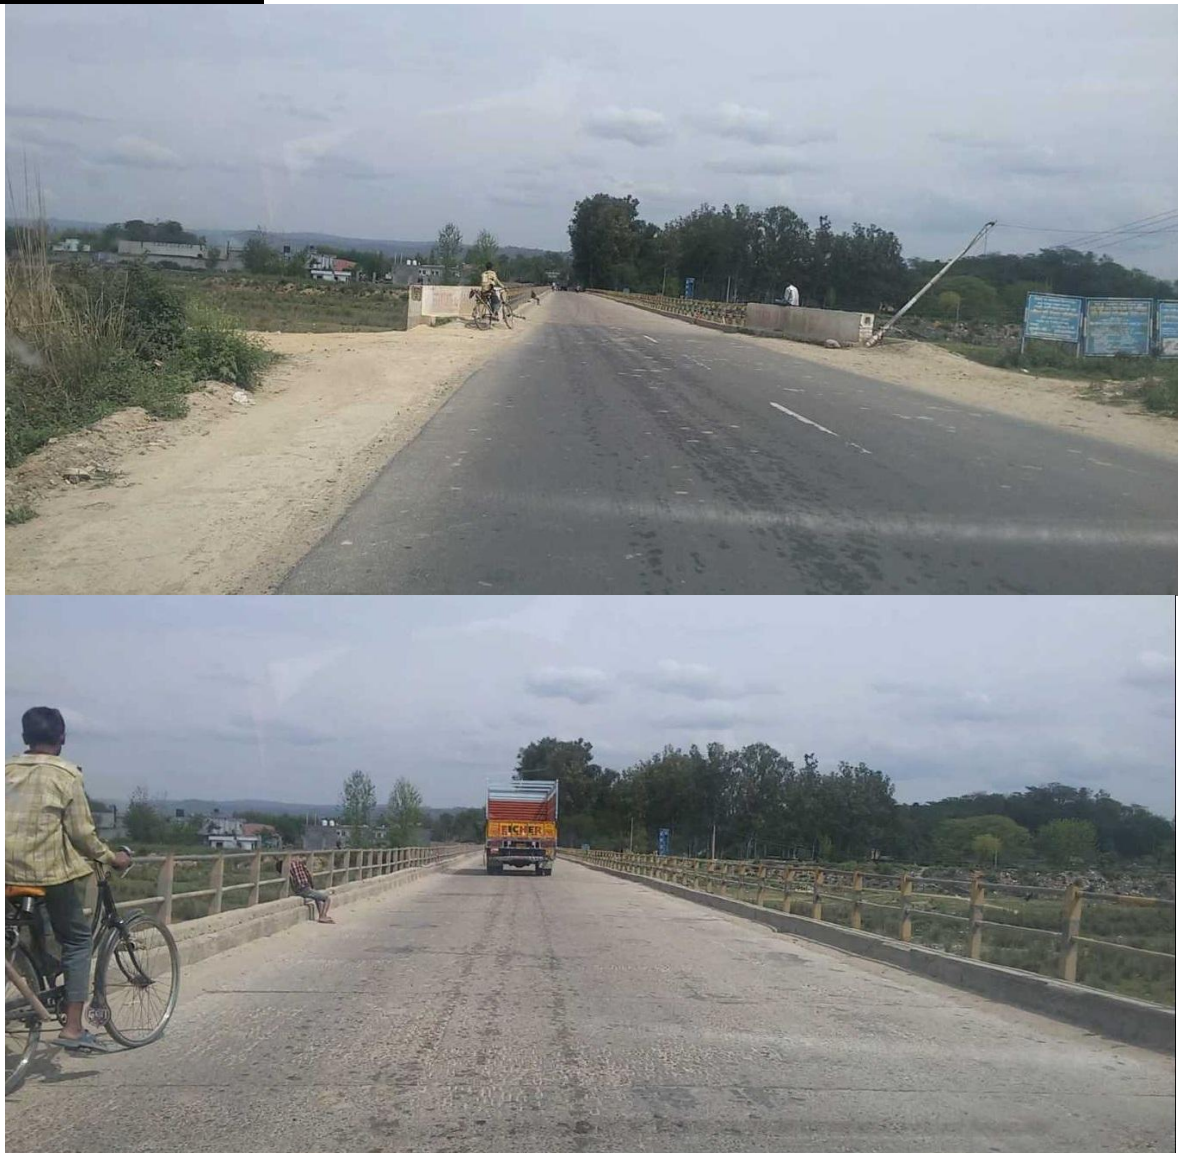
Fig 2.3: Near Alfa Hotel Gagret.

- This black spot point is near Alfa Hotel Gagret. Here the width of carriageway and shoulder is satisfactory.
- But on the bridge no space for pedestrians for walking.

- Provide the marking on the road as well as on bridge also.
- Speed limit sign board.
- Before the bridge provide/install the “Narrow Bridge” sign board.
- Provide the safety barriers just before the bridge starting on both sides of road.

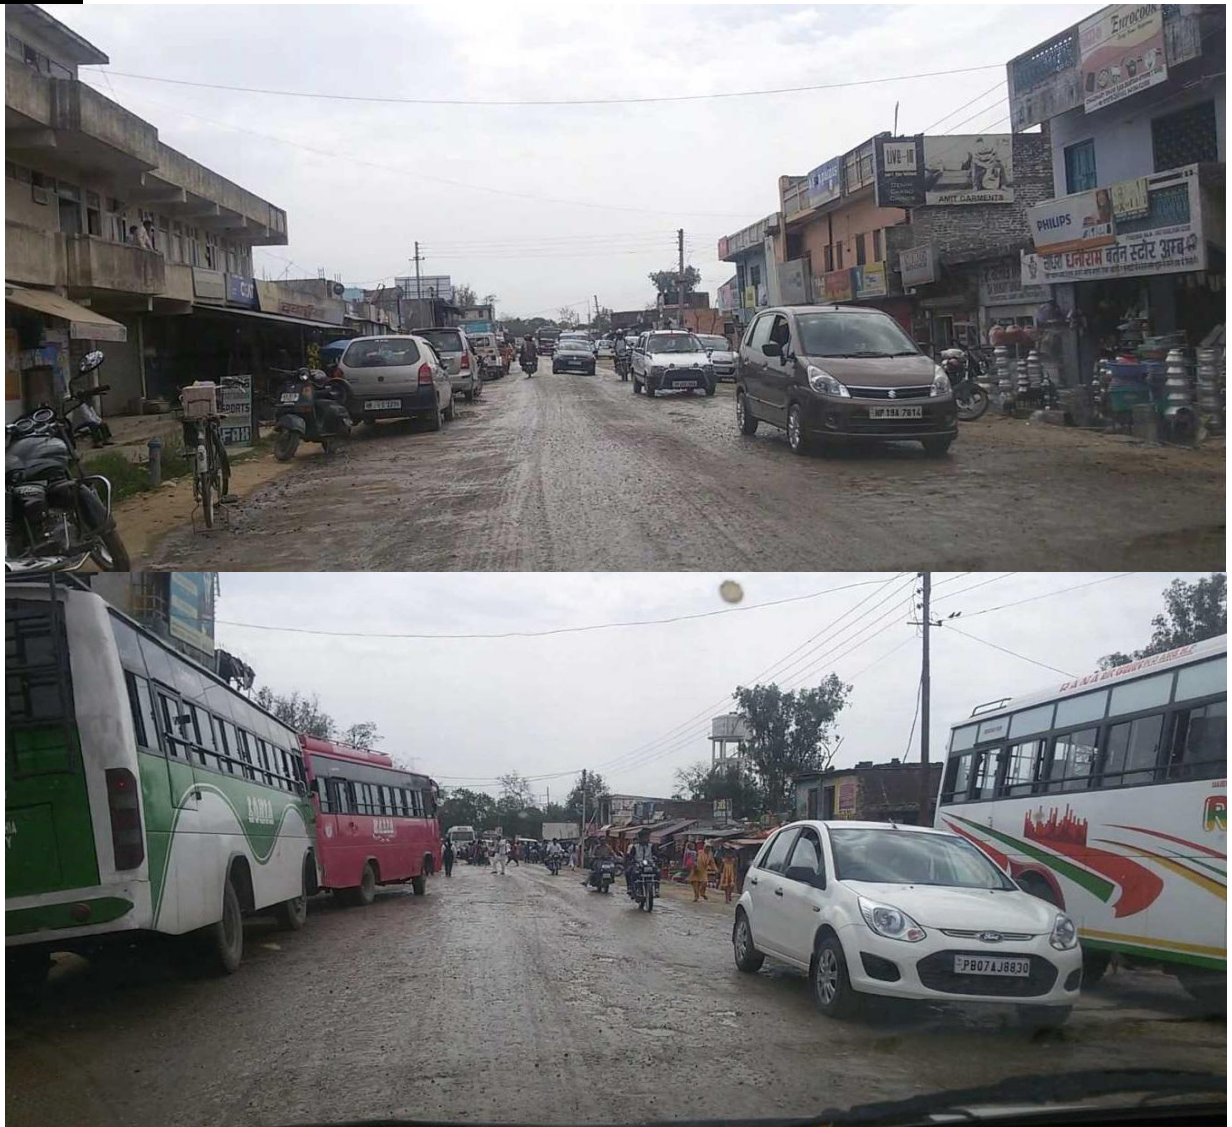
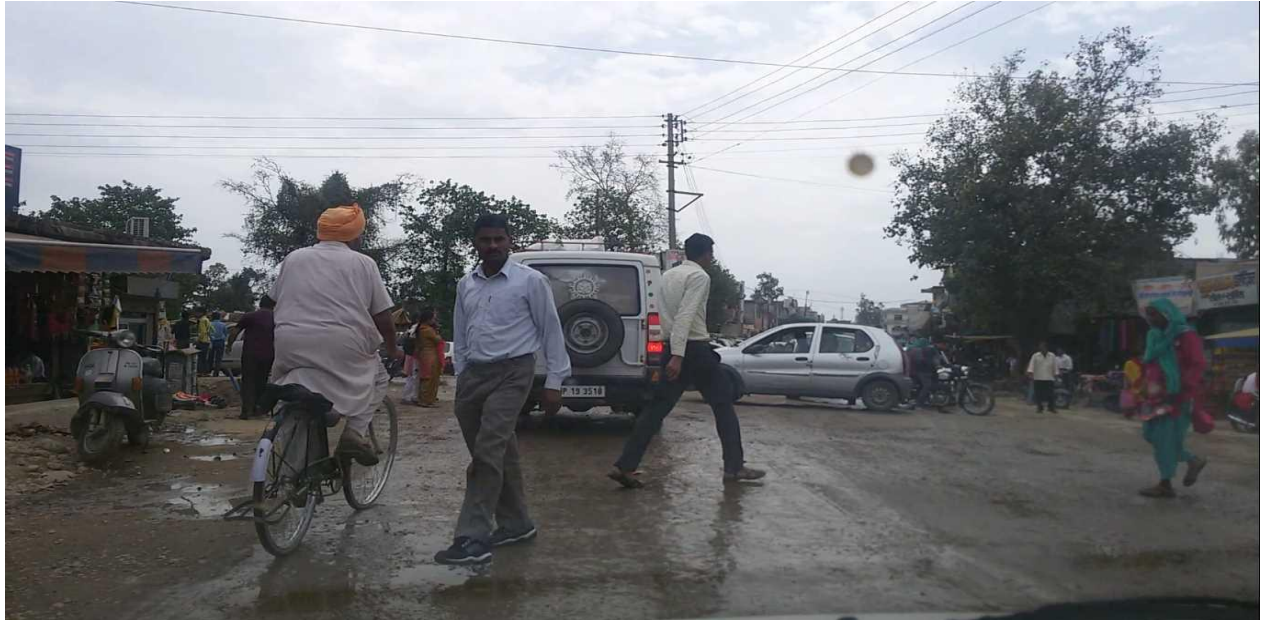
Fig 2.5: Amb city.
Source: Site visit photography.

This spot is near the bus stand and market of Amb city.

- Here the condition of road is not good but the construction work is going on here.
- No marking on the roads.
- No zebra crossings.
- No space for parking.
- Also sometimes the buses are stop on the side of road.
- On intersection of road, no rotary or signal is provided because of which the jams conditions occurs here.

- Provide the markings on the road.
- Provide the zebra crossings near the bus stand and junction for safe crossing of the pedestrians.
- Provide the parking so that vehicles cannot be stand on the side of the road which creates the problem for pedestrians and for vehicles also.
- No bus should be stand on road which is the responsibility of the traffic police.
- Provide the rotary or signals on junction where the roads are crossing.
- Provide the speed limit sign boards in the city on National Highway.
