**AN EXPERIMENTAL INVESTIGATION OF GEAR PITTING SURFACE FATIGUE FAILURE**

*Abstract*

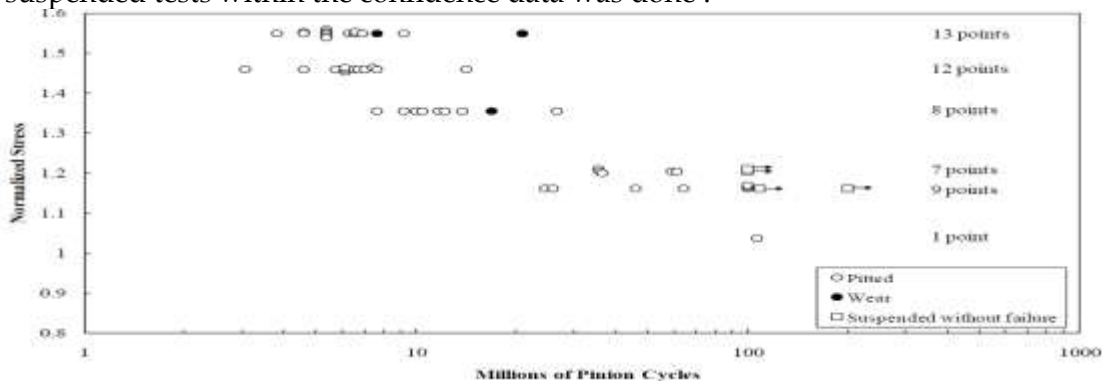
Figure 2: Normalized pinion pitch line stress versus pinion cycles for HS gears.

Although the number of cycles for the pitted specimens does not exceed 60 million pinion cycles, the 90% Confidence Interval occurs at approximately 70 million cycles. This result occurs from the inclusion of the two tests suspended at 100 million cycles with no pits. Weibull distributions were calculated for each of the load levels of the HS tests. Unlike the confidence intervals mentioned above, these Weibull distributions did not include suspended tests and, therefore, have less data points. Although the roughness values for the HS and ground specimens were very similar to each other, it was also worthwhile to make a comparison of  $R_q$  roughness values between the specimens. Higher values in these  $R_q$  values would suggest a greater variation in asperity contact magnitudes along the tooth surface and may influence the contact fatigue life of each specimen. For the HS gears the average Surface Roughness ( $R_q$ ) value was  $0.5001\mu\text{m}$ .

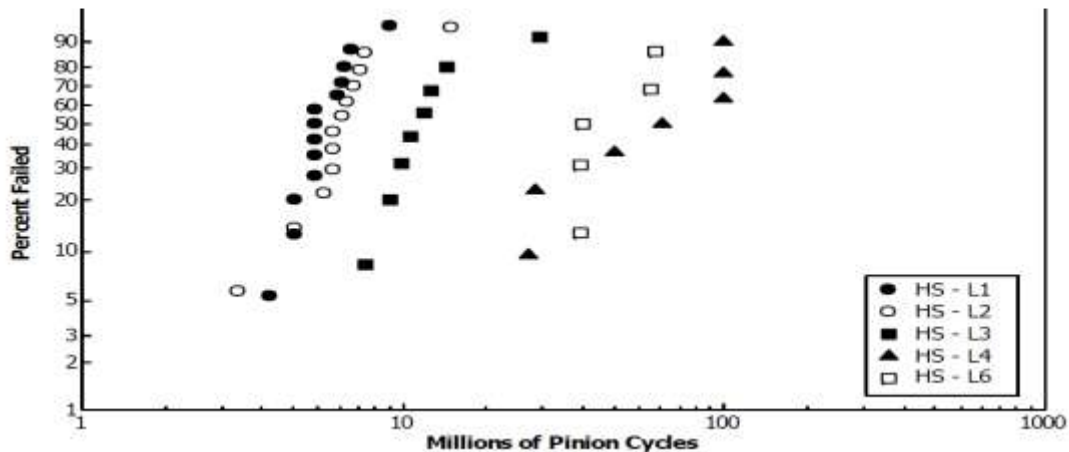
Figure 3: Weibull distributions of HS pitted tests at different load levels.
